# Kennedy/Jenks Consultants

5 February 2001

Subject: Report of Destruction of Well WCC-10S  
Boeing Realty Corporation Former C-6 Facility  
Los Angeles, California  
K/J 004034.00

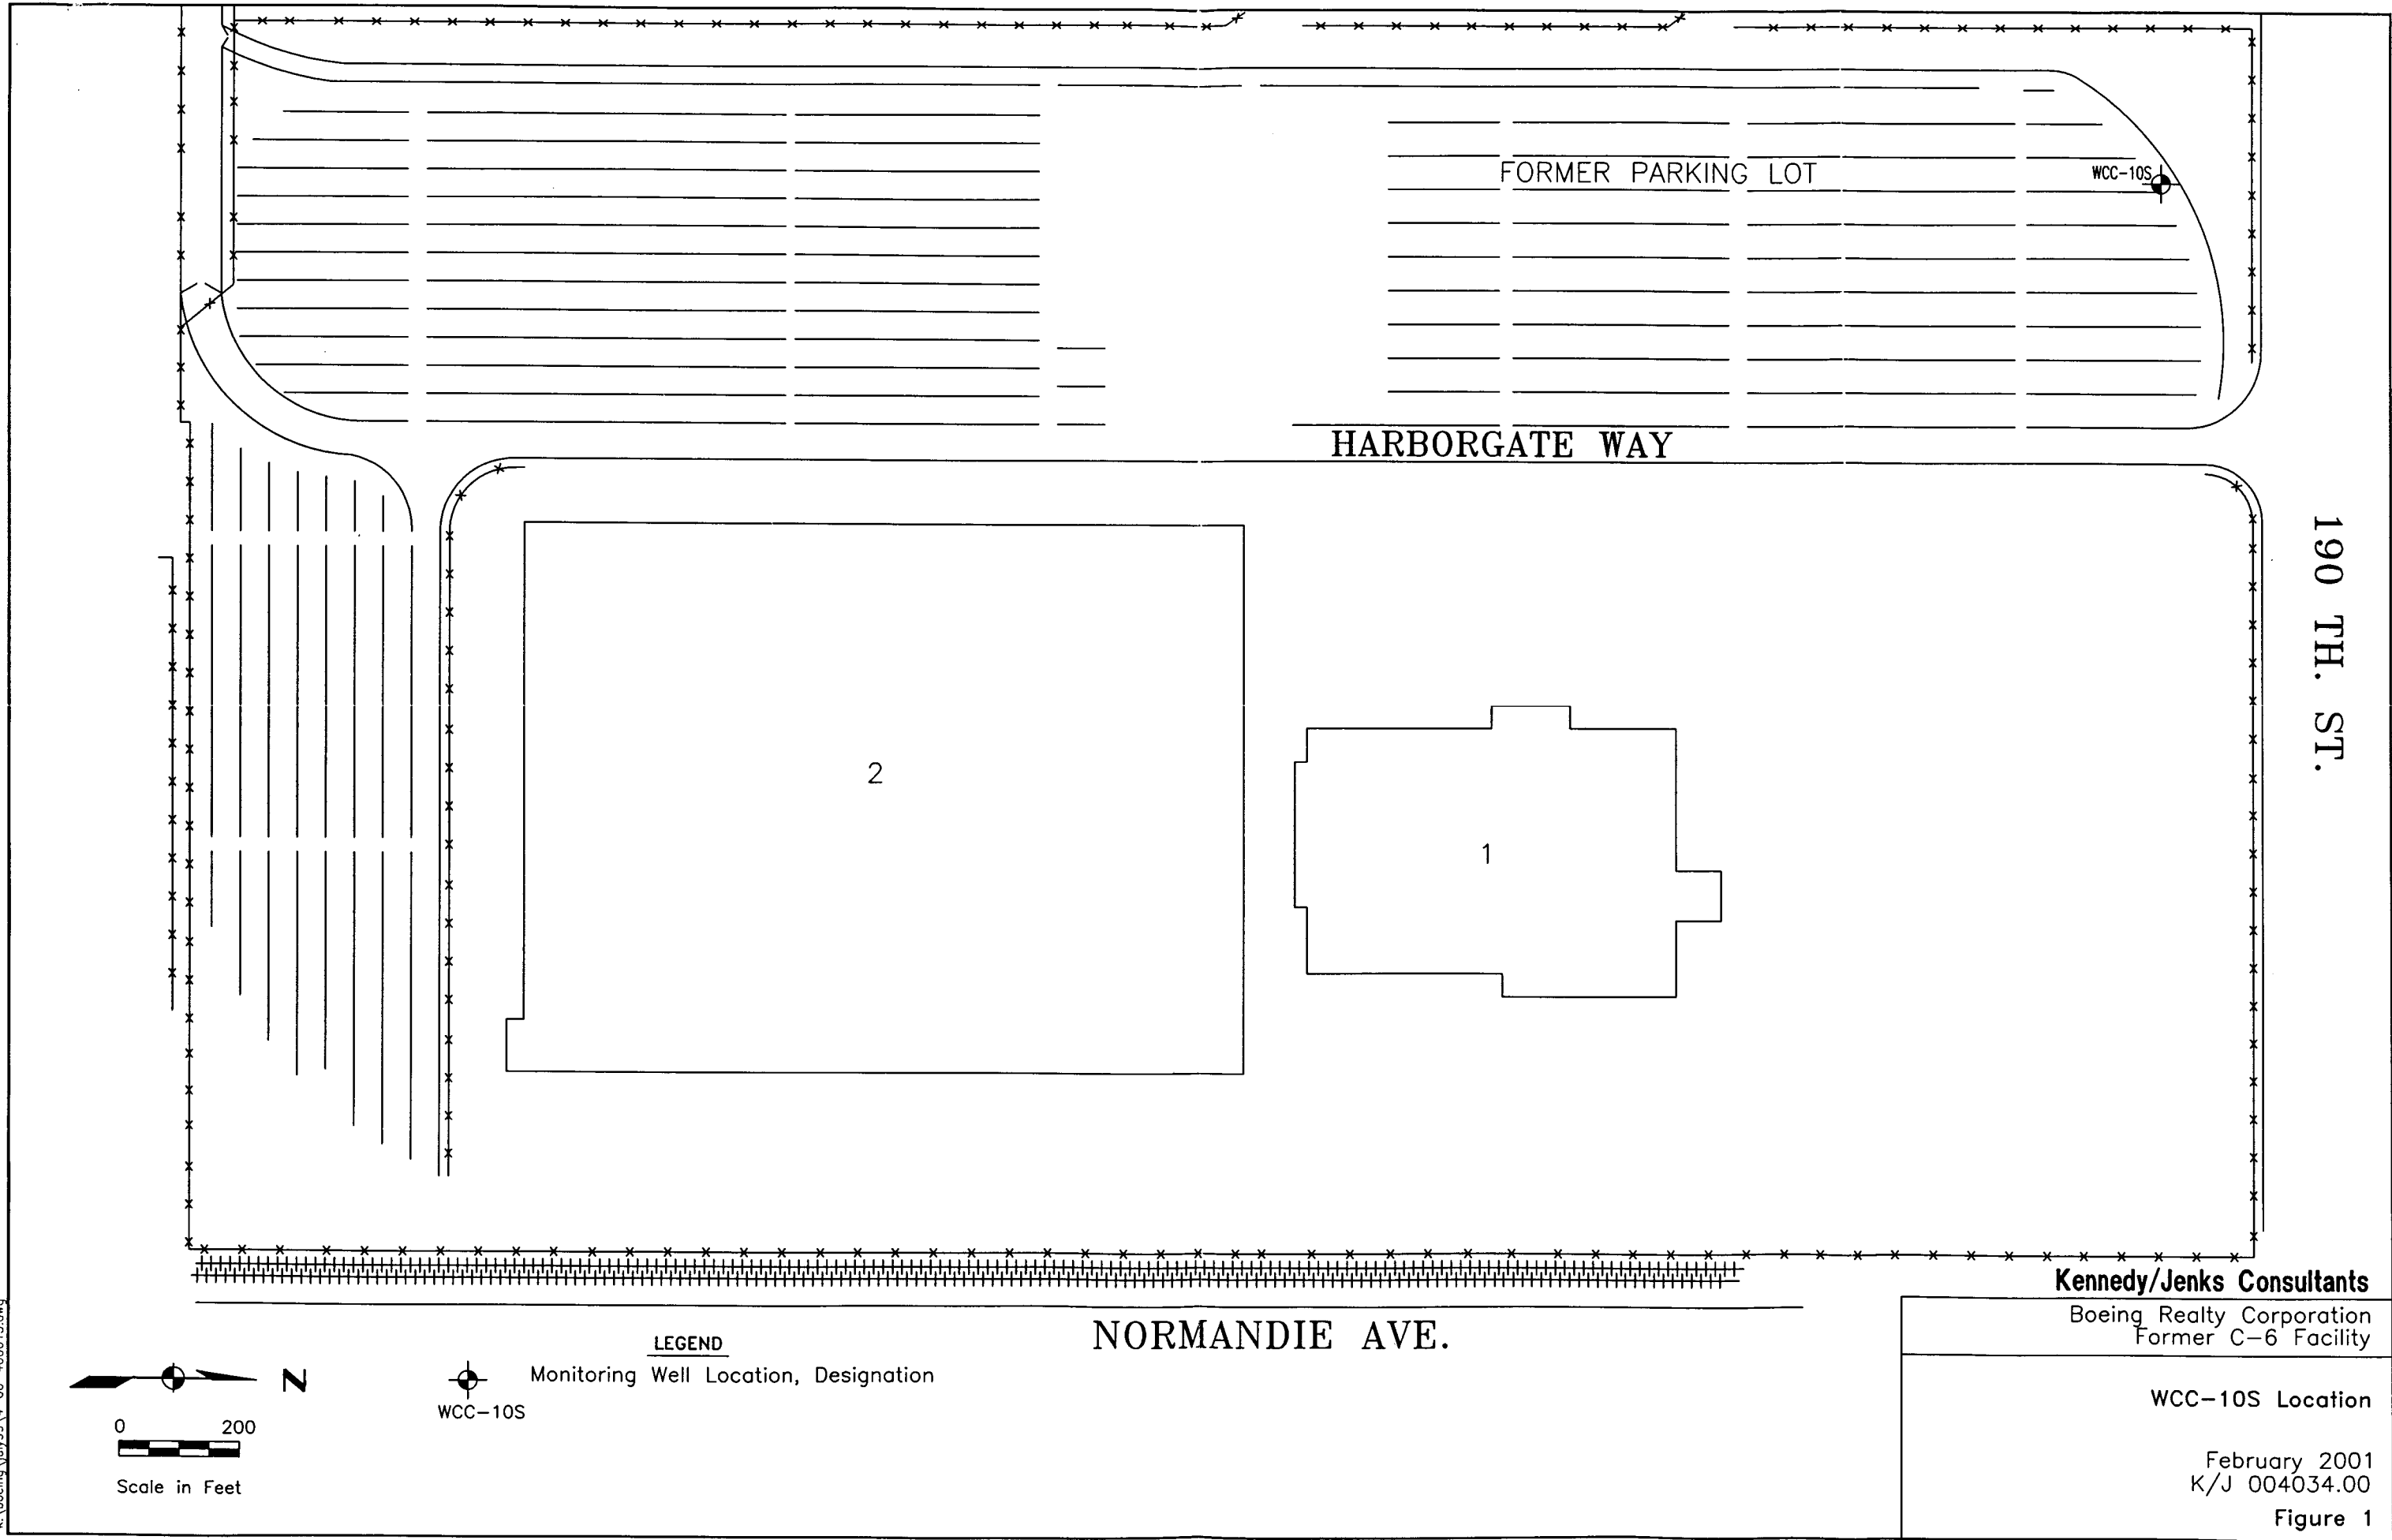
Groundwater monitoring well WCC-10S was located in the northwest corner of the Former C-6 Facility (Figure 1). Well WCC-10S was constructed of 4-inch PVC casing, and was 90.8 feet deep with a screened interval from 60 to 90 feet below ground surface (bgs).
